# Framework

## DELIVERABLE 18

### Structural Testing

# Structural Testing for the Framework Project

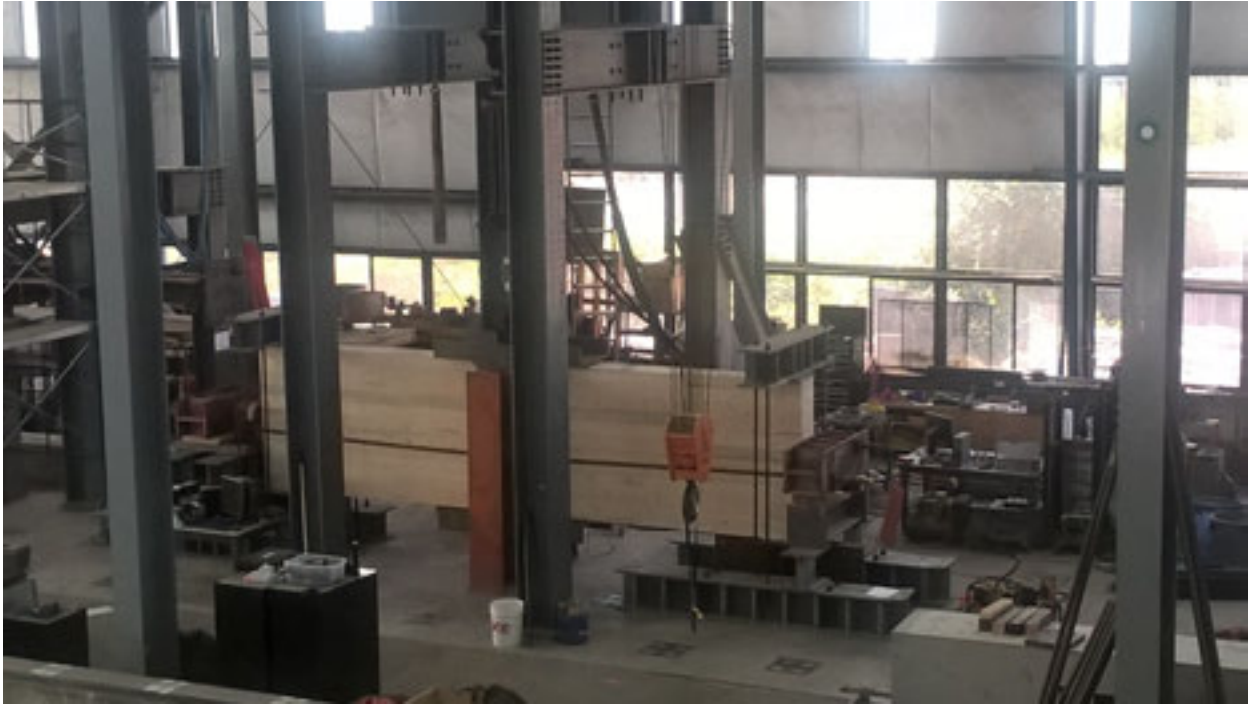
Figure 3 – Schematic 3-D view of test setup with typical CLT9 wall specimen.

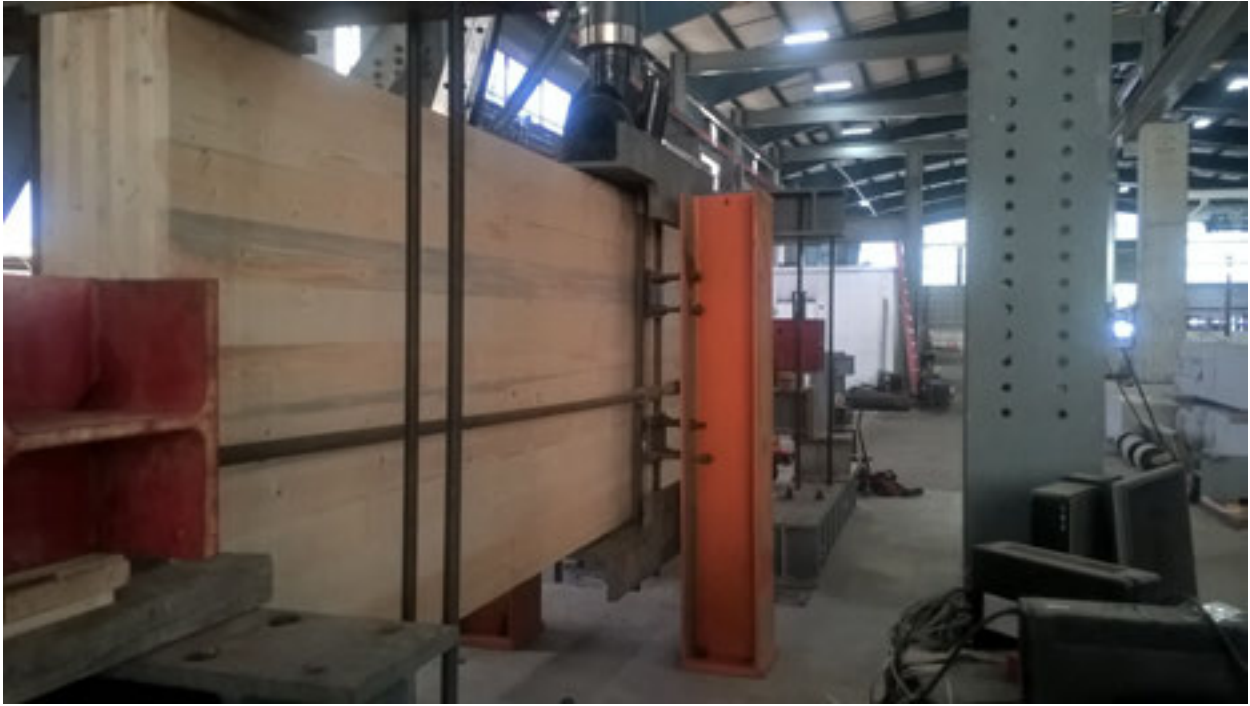
Figure 4 – Overview of Test Setup for CLT9 Wall Specimens.

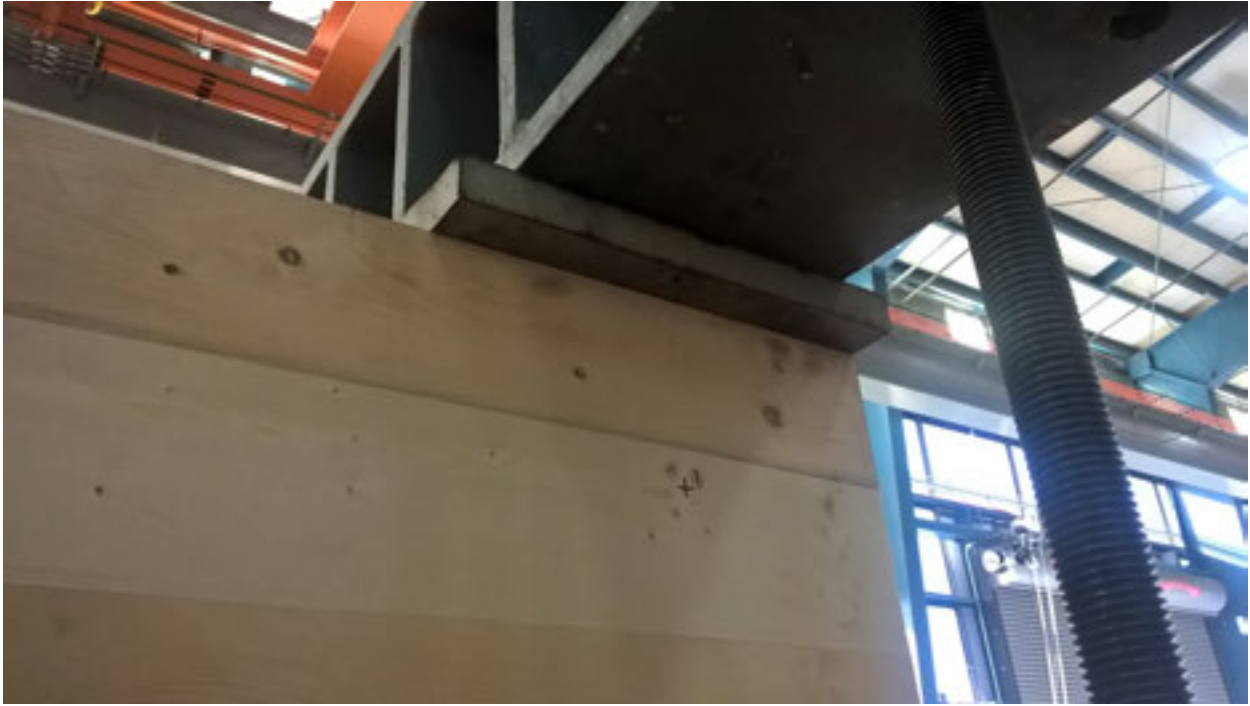
Figure 6 – Close-up of Axial-Load Jack and Load Cell (view from South).

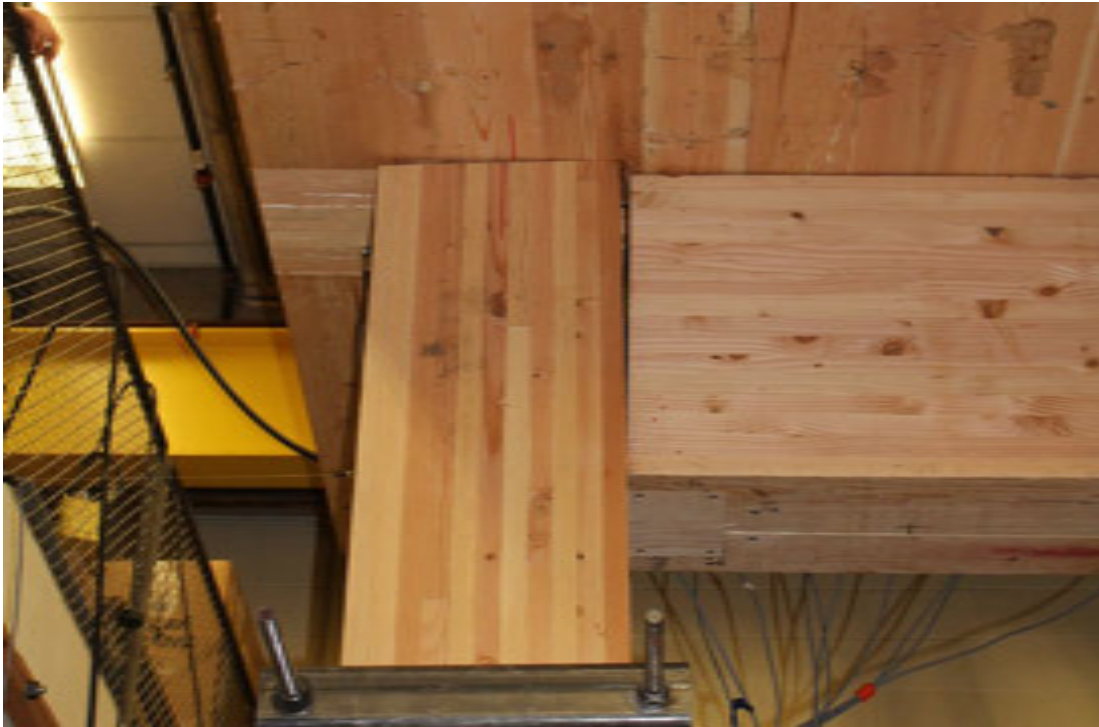
**Figure 15 – Connection at 3% positive drift**

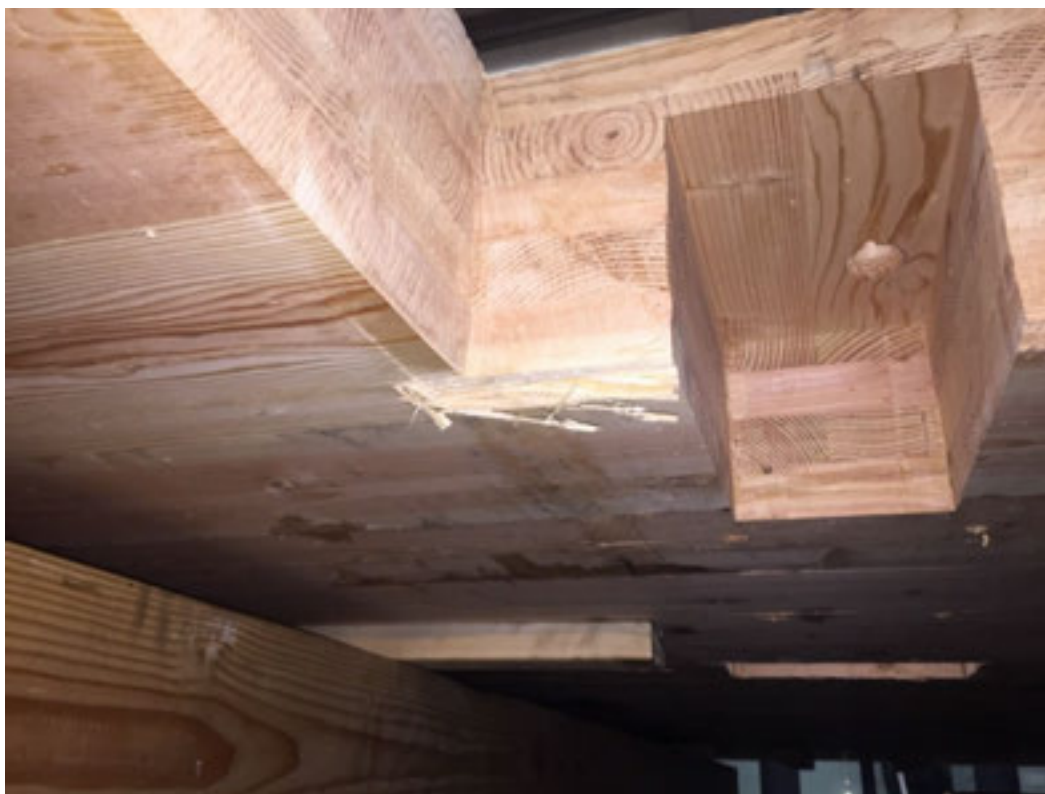
**Figure 17 – Splintering on edge of CLT-5 Panel post-Test 1**

- The CLT-5 panel was in contact with the top of C01 prior to the start of testing and was observed to rub on the top of C01 during all displacement cycles of Test 1. This resulted in localized splintering along the edge of the CLT-5 panel nearest the BTC connection as depicted in Figure 17.

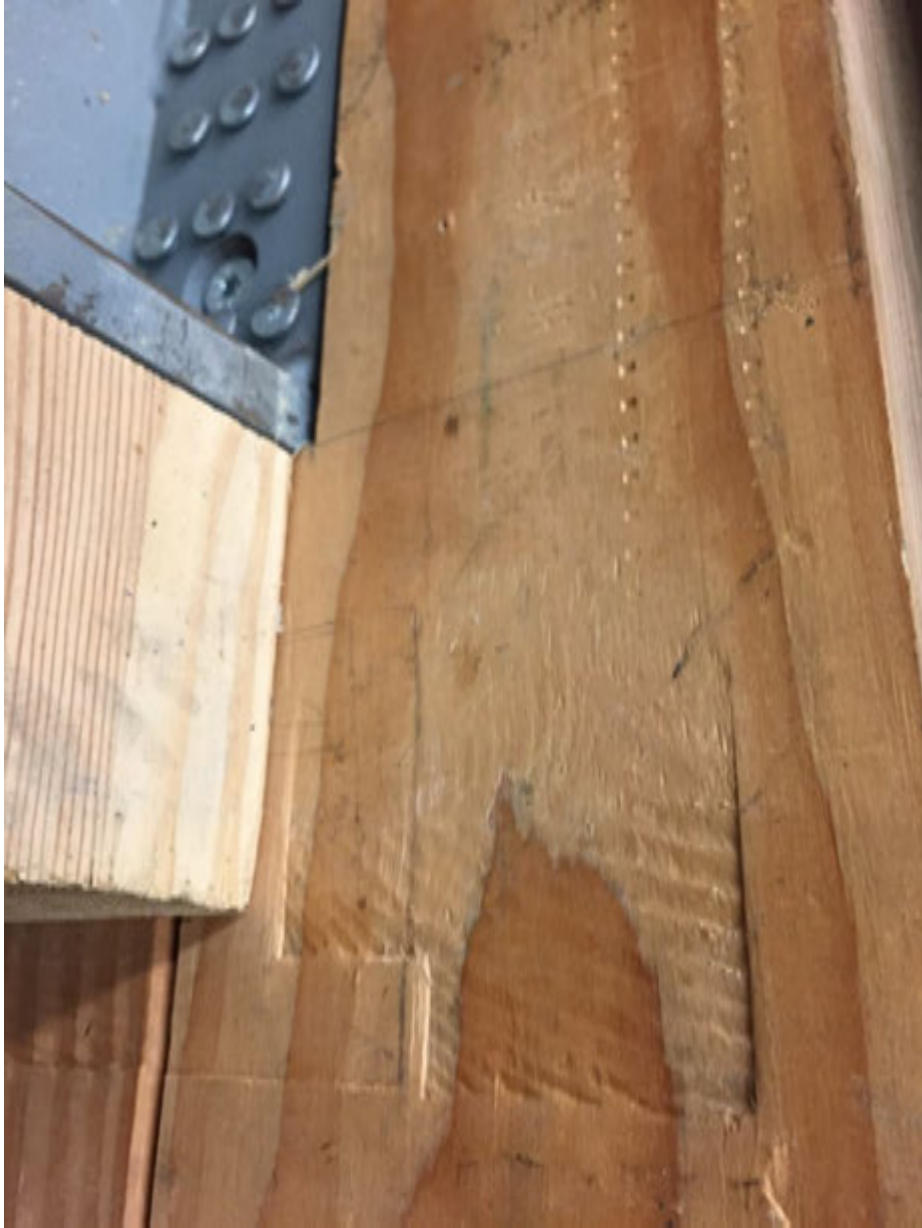
**Figure 23 – Localized crushing of face C02 after 6% drift cycles**

- Similar to Test 1, a crushing region was observed on the beam-side of C02 where B02 bared against the column during positive displacements as shown in Figure 23. This crushing did not appear to have caused any major structural damage to B02 and C02 and maximum crushing depth was limited to approximately 1/16".
